# Manhole Inspection Summary

Manhole # S31EE\_024MH

Insp Date: **1/25/07 8:44 AM**

**Location** Address: **HOWARD ST**

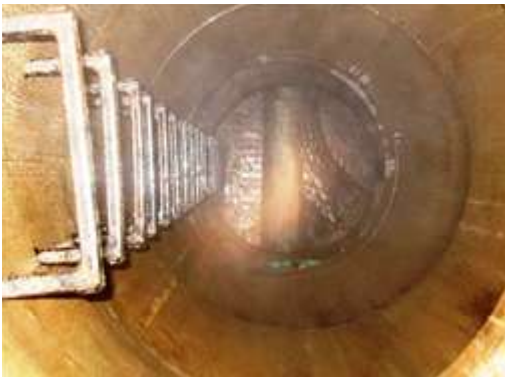
☒ **Debris** (not Condition related)

Bench debris.

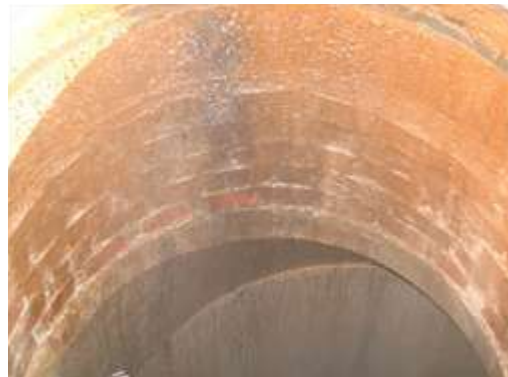
☒ **Leaks**

Infiltration: ☐ None ☒ **Joint** ☐ Cracks ☐ Mortar ☐ Roots ☐ Wall

Frame leaks. Adjustment infiltration.

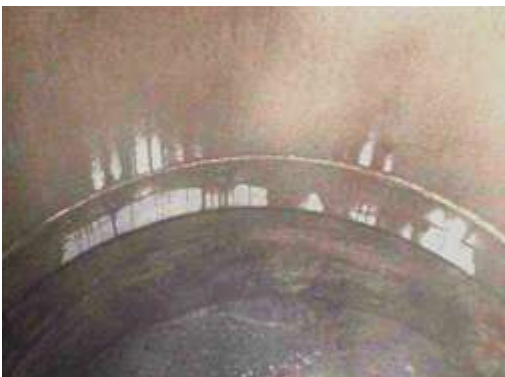
Infiltration: ☐ None ☒ **Joint** ☐ Cracks ☐ Mortar ☐ Roots ☐ Wall

Barrel infiltration.
